Black Sea P&I Review 2008

P&I Review 2008 - Novorossiysk (by Oleg Shashkin)

P&I Review - Odessa 2008 (By Adv. Pavel Svertilov)

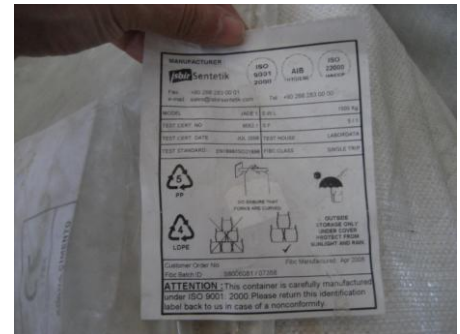
Among the other factors, damage to packing occurs when the stowage instructions of producers and packers of this cargo are ignored. It should be known that most such packing - soft big bag IBC’s should be stowed by shippers not more than two tiers in height. This is clearly marked on the packing manufacturers’ label attached to the bag. In the meantime

contrary to such requirements the majority of vessels carry such cargo stowed on board 4 and 5 tiers high. In such cases bags in the lower 2 – 3 tiers cannot endure the weight of the bags in the upper tiers and they burst sometimes causing collapse of the stow. In some cases the contents of the lower tiers can be damaged by compaction and become hardened.

Recommendation: Awareness of the problem and its consequences when concluding charter parties.

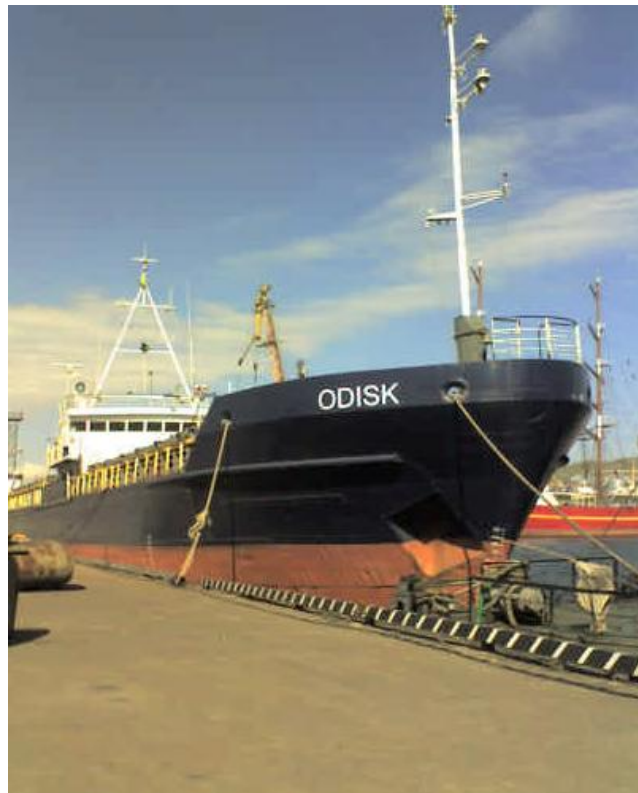
- The cargo in the land storage site was not adequately protected against weather conditions, especially atmospheric precipitation rain, dew etc.
- The cargo in tracks alongside the vessel was exposed to rain.
- Hole in drain channel in hatch cover in the hold, and missing rubber also created a possibility for water ingress into the hold. Signs of water leaks on portside bulkhead confirm this possibility.
- Lack of tightness, which we found on manholes covers of both holds, provided a possibility of gas leaking from holds to alleyways/side galleries.
- Cabins of both dead crewmembers were located on main deck and portholes were opened, enabling gas to penetrate into the cabins.
- Cargo holds were ventilated, however contrary to Code requirements; only one ventilator per hold was utilized.

In summary, intoxication of crew members occurred due to evolving and concentration gas phosphine from the holds where the chemical cargo of ferrosilicon was loaded during the rain in wet condition.

Pic. 1. m/v "Odisk" berthed of Kerch port under authorities' investigation – April 2007

- Contingency plan should be in place, and crew members must properly trained and equipped to operate with poisonous cargo.

- Cargo space must be properly ventilated by enforceable fans in the holds during voyage. Fans should be either explosion-proof or arranged so that the escaping gas flow is separated from electrical cables and components. Ventilation should be such that any escaping gases cannot reach living quarters on or under deck space.

- Chemical cargo of ferrosilicon must be stored in elements protected area.
- In case of commencement the rain cargo operations must be stopped immediately with immediate notification to Ship-owners/P&I Club;

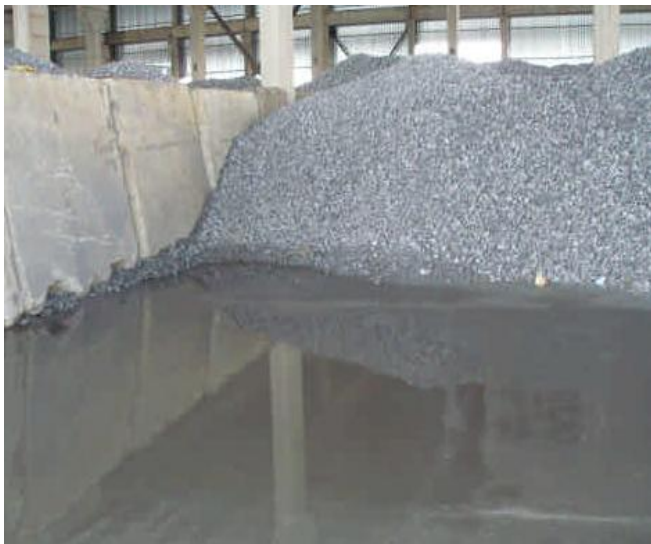
*Pic. 2. Cargo of ferrosilicon in wet condition.
View 1*

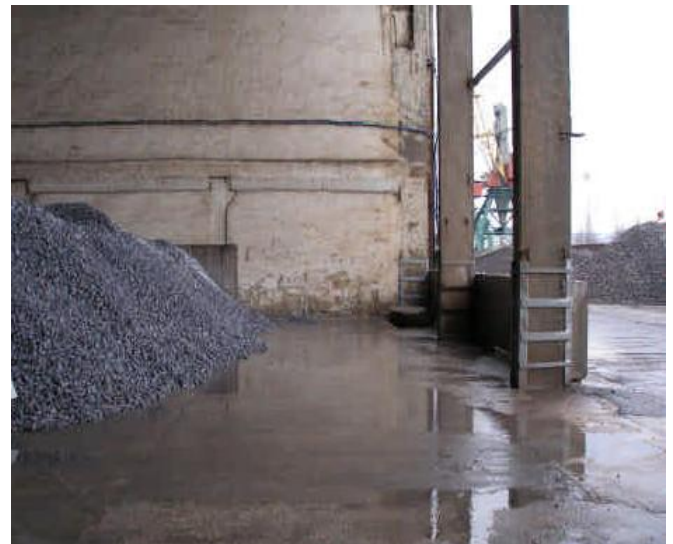
*Pic. 3. Cargo of ferrosilicon in wet condition. View 2.
As it is apparent from photos, despite the fact, that cargo is stored in shed warehouse, part of the cargo is located in puddle of rain water, cargo is partly wet.*

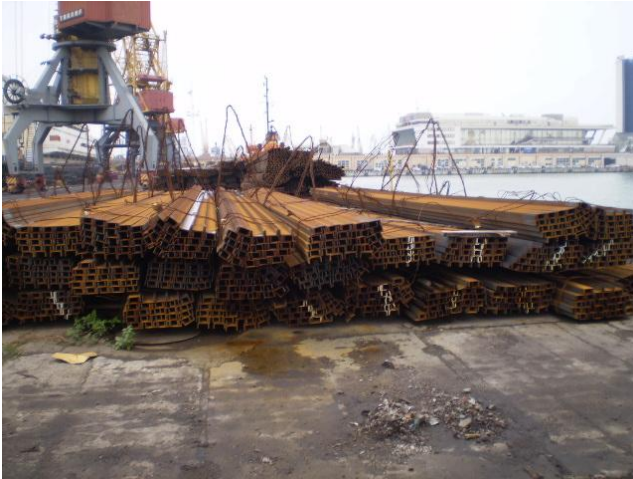
The most frequent damages are in steel cargoes transported from the steel-plants to the ports by railway using open platforms or open wagons and stored at open area in the port open ground unprotected from elements. In addition, sometimes oil and grease from port cranes and equipment stains the steel cargo.

Pic.4. Cargo stored at open yard unprotected from elements.

We recommend endorsing following general remarks regarding condition of Cargo into Mate's Receipt and Bill of Lading and issue to Master appropriate surveyor's letter:

- Cargo stored at open yard unprotected from elements;
- Cargo partly rust stained, rust spots apparent;
- Number of coils: inner and/or outer windings bent and/or dented to various extent up ___to ___ windings affected);
- Cargo wet before shipment;
- Cargo stained with oil or grease patches;
- Number of bundles: bundles envelope dent/deformed in different extent;
- Number of bundles: one or more strapping bands torn/missing;
- Number of bundles: envelopes torn open/punctured revealing.
- Number of bundles: strapped insufficiently, wire strap loose;
- Number of plates with corners/or edges bent;
- Some plates partly covered with coal and/or chemical dust.

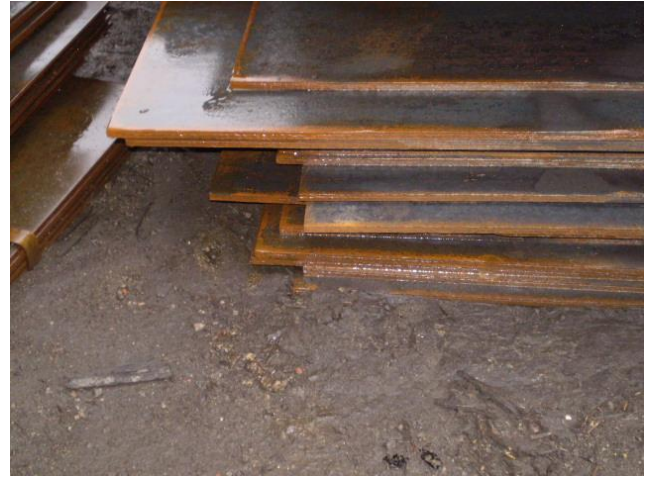
Pic. 5. Cargo partly rust stained.

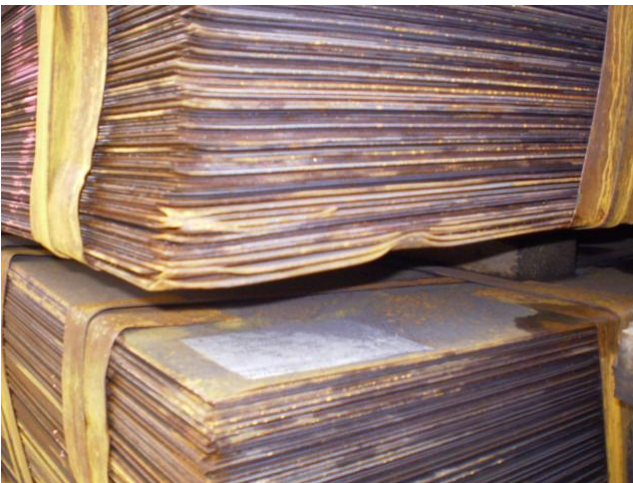
Pic. 6. Sheets with dented/buckled corners.

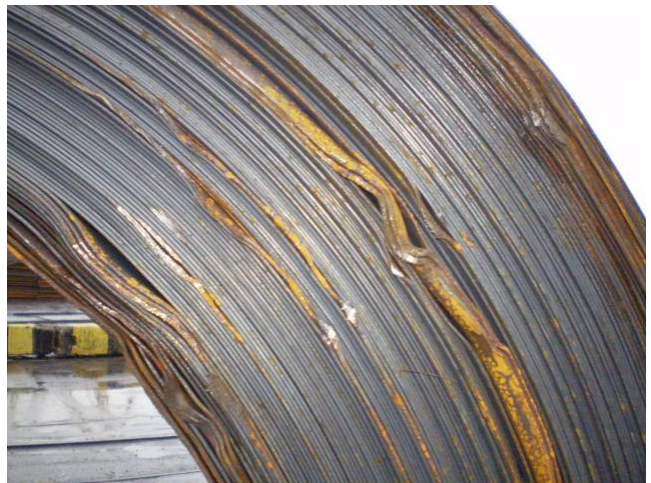
Pic. 7. Coil with buckled inner/outer windings
