Black Sea P&I Review 2008

P&I Review 2008 - Novorossiysk (by Oleg Shashkin)

P&I Review - Odessa 2008 (By Adv. Pavel Svertilov)

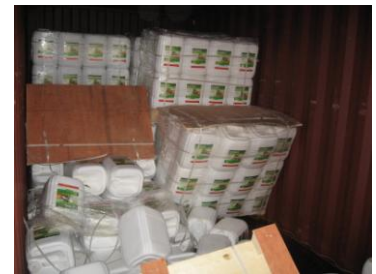
From time to time we see claims made against Container Lines (Carriers) due to shifting of cargo inside the containers during combined carriage (sea-rail-road). Shippers are trying to prove that they stow and secure container contents carefully, try to place the blame on the ocean carrier for alleged rough handling of containers. One of the defenses that the carrier tries to use is to argue is that since the container itself does not present any visible recent damages this is evidence of careful carriage and no claim is accepted. However,

studies of after-discharge handling and transport of containers shows that in some cases Russian Railways exceed the normal foreseen forces exerted on the contents of containers in multiple shunting operations even on relatively short distance inland journeys, and sudden deceleration such as during emergency braking of motor trucks on the road can produce similar effects.

Recommendation: Despite the above facts, it can be quite difficult to prove and carriers are recommended to request in such cases that the surveyor investigate and study the matters of stowage and securing of the cargo in a container as well as the usual damage in their cargo reports.

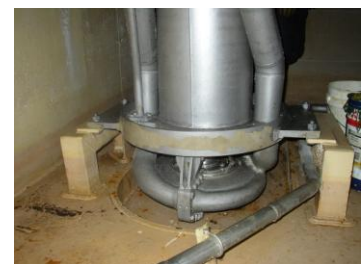
Product carriers often transport different bulk liquids in separate tanks – one consignment per tank. Such tankers are constructed with a hydraulically driven pump installed in each tank. In this way the ship can discharge a number of cargoes separately and independently from others. However the pump can also be a potential contamination source to a sensitive cargo by leakage of its hydraulic oil. A case recently managed occurred when cargo receivers claimed a large amount for contamination of a cargo of wine raw material allegedly caused by hydraulic oil determined visually during sampling.

Cargo was sampled and a claim for further security was requested from owners. Receivers also stated that they found similar contamination in samples taken from the consignment discharged into their own storage tanks.

However after analysis, it was revealed that the cargo taken from ship's tanks and visually considered contaminated was not damaged nor mixed with any contaminant, but was of a bad quality which further deteriorated during carriage, even though the transport was performed in order, and under all

Recommendation: Ensure that shipper's samples are supplied and carried on board, and draw and retain sealed and stamped samples jointly with other interested parties to form their own independent sets of samples.
